# Corrosion Test TEST REPORT

## Of ISO 9227:2017 Applied for SASO-2927

<b>Beschreibung des Produkts:</b> <i>Product Description:</i>	LED STREET LIGHT
<b>Modelle:</b> <i>Models:</i>	AOK-150WiL02-NV-L3-00-40
<b>Bewertung:</b> <i>Rating:</i>	AC120-277V, 50/60Hz, 150W, 1560mA
<b>Verfahren:</b> <i>Method:</i>	SASO 2927: 2019:Energy efficiency functionality and labelling requirements for lighting products – Part 3: Street lighting ISO 9227:2017: Corrosion tests in artificial atmospheres—Salt spray tests
<b>Prüfergebnis*:</b> <i>Test result*:</i>	The Rating 8 classification after corrosion test 2,500h

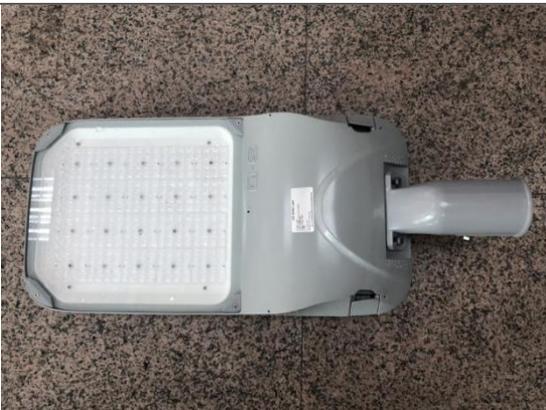
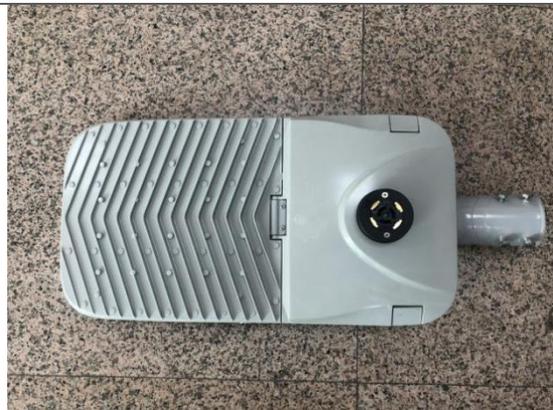
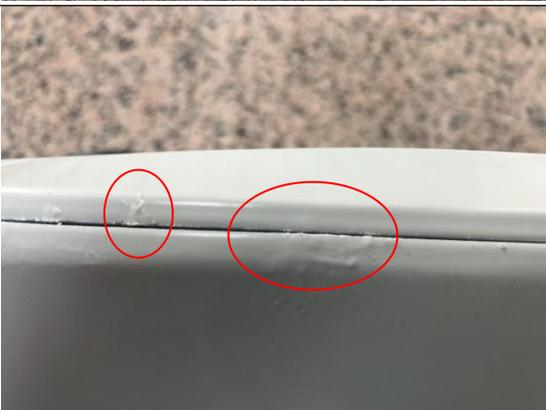
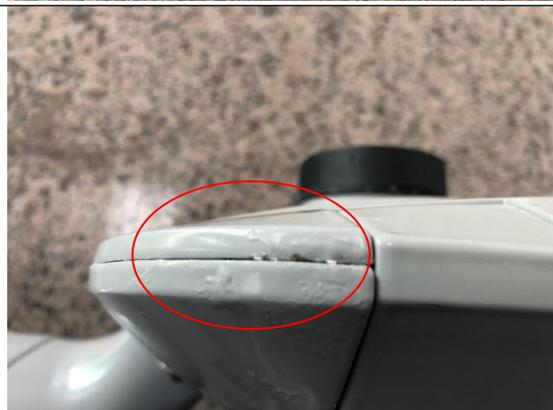
Sample Photo after the Test:

## 7. Test Results: After tested, the sample appearance had not obvious corrosion and function was normal

Sample No.	The classification after 2,500	Verdict
1	8	After the test, only a little corrosion on the sample surface.
Remark: AOK-150WiL02-NV-L3-00-40 model
